Media Release – Hercules Engineering – September 2015

# Sydney Markets ramp upgrade provides quality answer to challenges posed by increasing loads on Australia's carparks

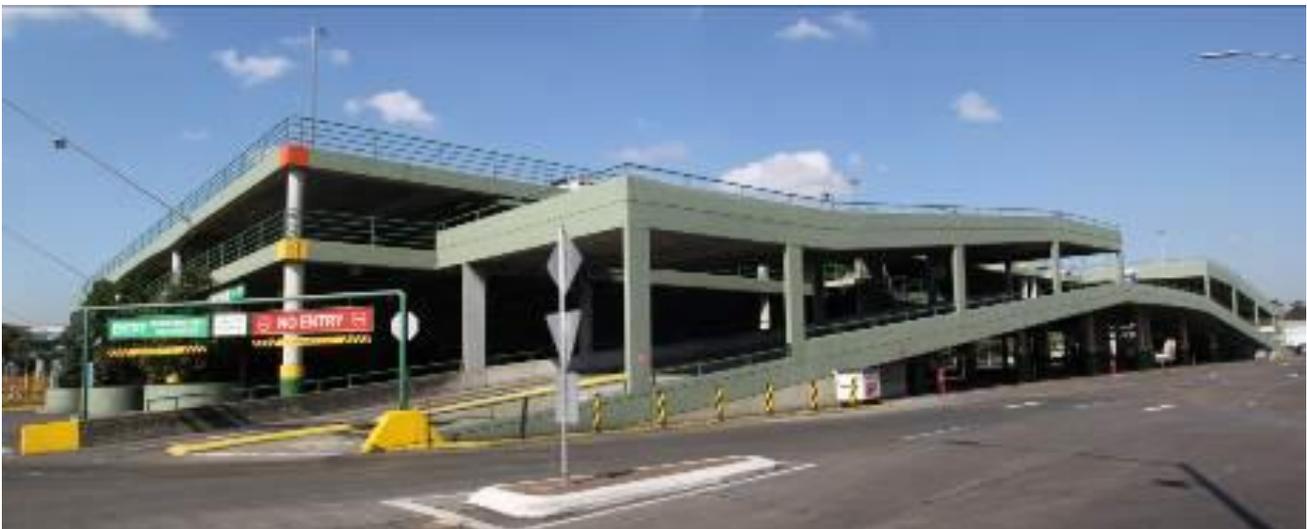
*The Sydney Markets carpark where the ramp upgrade was undertaken by RKR Engineering, as designed by Griffiths Engineers for Sydney Markets using Hercules slip joint technology*

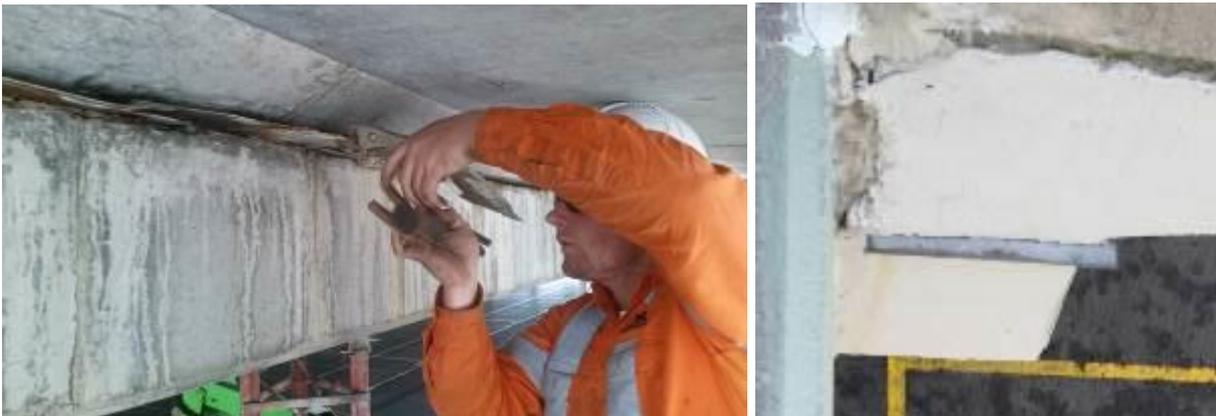
*Extraction of the old slip joint being removed by RKR Engineering team, left and close-up of the slip joint, right*

The solution to the challenges at Sydney Markets involved a custom-engineered Hercules slip joint, produced to the specifications arising from Griffiths Engineers’ report on the issue.

The joint, which runs the full width of the ramp, utilises two layers of stainless steel, Grade 304, 0.55mm thick and 200mm wide, with graphite grease applied between layers.

Grade 304 stainless steel was specified to prevent corrosion or seizure over time, which were problems with the original joint. The new joint is configured to allow the two layers of concrete to move fractional amounts separately, to allow for applied external forces and movements and prevent the concrete from cracking.

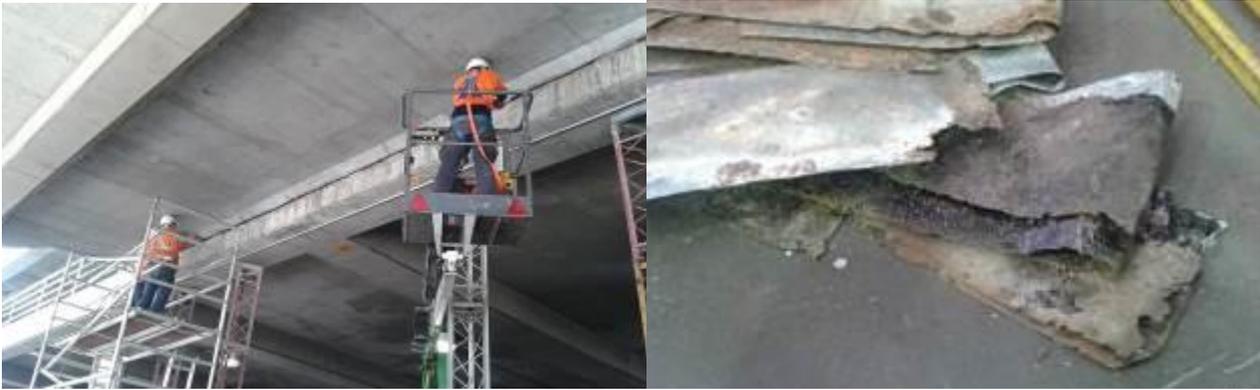
The original joint comprised two sheets of galvanised iron, which, with large amounts of corrosion, had bound together and prevented lateral movements (induced from concrete shrinkage, thermal changes and vehicular momentum from braking and accelerating).

*Installing the new bearing, left, and the deteriorated original slip joint*

For installation, the supported slab was jacked up to allow the original slip joint to be removed and the new bearing to be installed properly.

known to harden and set over time. The graphite grease used in the specified Hercules joint does not contain an aluminum complex thickener, but rather uses a lithium/calcium soap, which is known to be stable over the long term.
